Technical Report HL-96-22
December 1996

Demonstration Erosion Control Project Monitoring Program

Fiscal Year 1994 Report

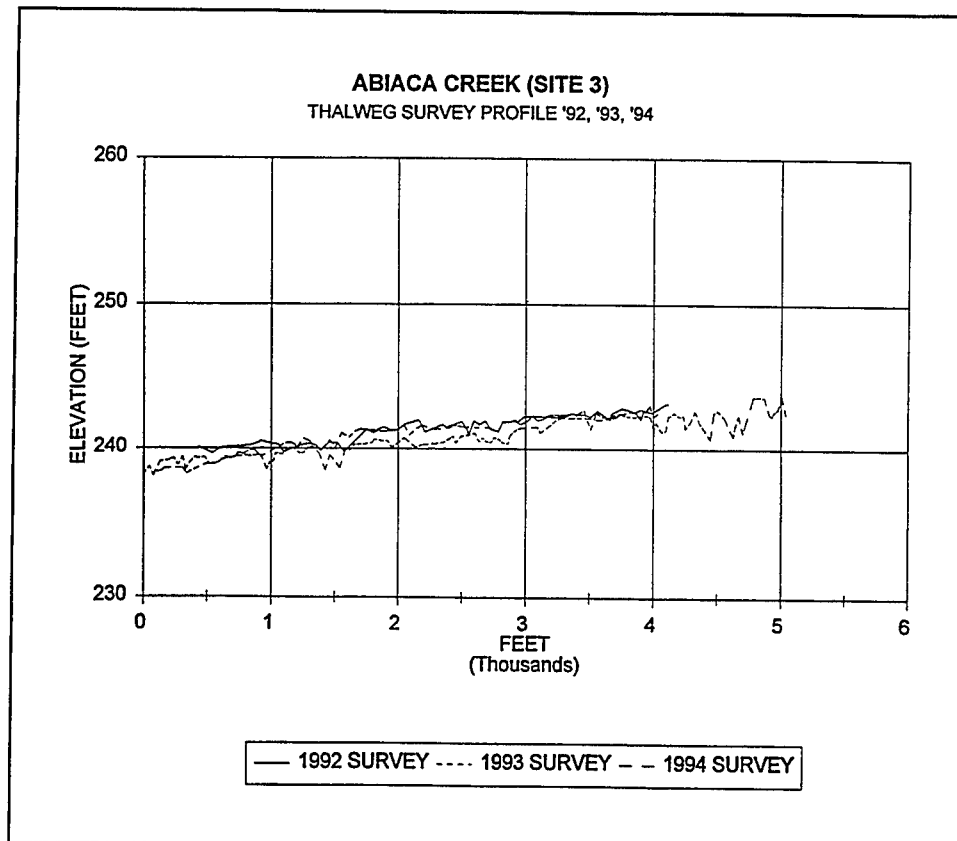
Figure 5. Abiaca Creek, Site 3, thalweg profile

Site 3, shown in Figure 4, is located in T17N, R3E, Section 20, at the Highway 17 crossing of Abiaca Creek. The approximate watershed area at this site is 26.5 square miles. This site was selected because of the relative stability of the channel at this location, and the fact that it is upstream of the gravel mining location. The streambed at Site 3 is composed primarily of sand with minor amounts of gravel. The banks are generally well-vegetated with mature vegetation down to the low-water surface; however, erosion of the outside bank of the bendways was noted. There is notable bank erosion on the upstream portion of this site extending upstream of Highway 17 where a bend is actively migrating. This is a local erosion situation, with no indication of overall system instability. Bioengineering methods could be used to stabilize these sites. The thalweg profiles (Figure 5) indicate that local variation, primarily scour, has occurred on the order of 2 to 3 ft vertically.

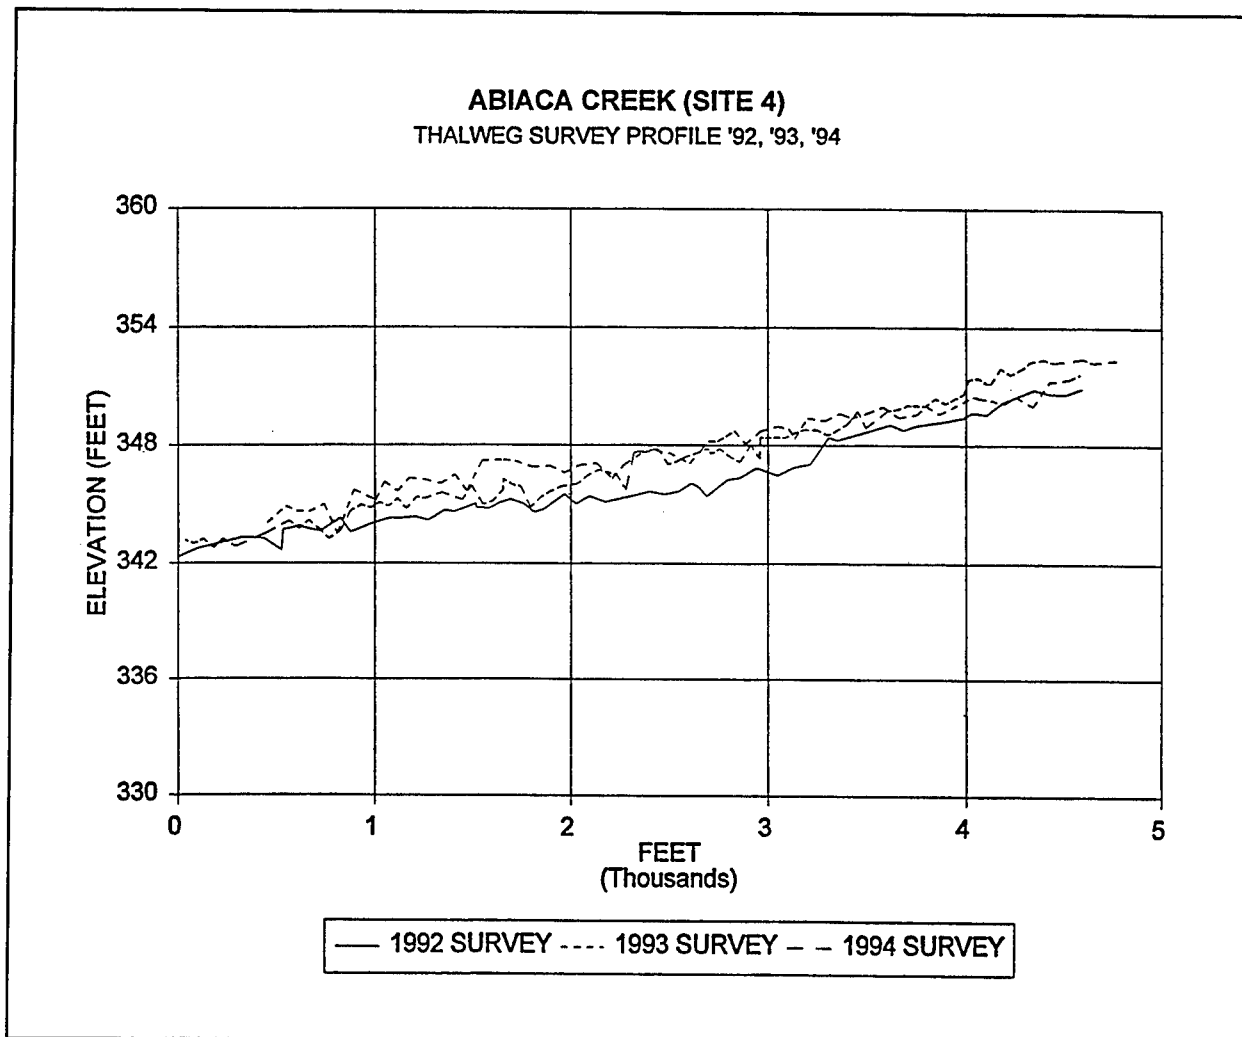
Figure 7. Abiaca Creek, Site 4, thalweg profile

Site 4 is on Abiaca Creek and extends approximately 4,000 ft upstream from the confluence of Coila Creek as shown in Figure 6. This site is located in T17N, R2E, Section 4, and has a watershed area of approximately 44 square miles. Site 4 is located approximately 1.8 miles downstream of a major sand and gravel processing operation that can be associated with an increased supply of suspended and bed material load. Streambanks in this reach are relatively stable and the bed gives the appearance of an aggraded reach. The most significant change in this watershed has occurred at the confluence of Abiaca and Coila Creeks, indicating aggradation since 1992 (Figure 7). During the October 1994 field inspection, Abiaca Creek flow was a milky, high suspended sediment load flowing into a relatively clear Coila Creek flow. The island immediately downstream of the confluence had shifted to a bar attached to the right bank, with all flow along the left bank. The downstream 500 ft of Coila Creek is actively eroding and the confluence may shift downstream by next year.

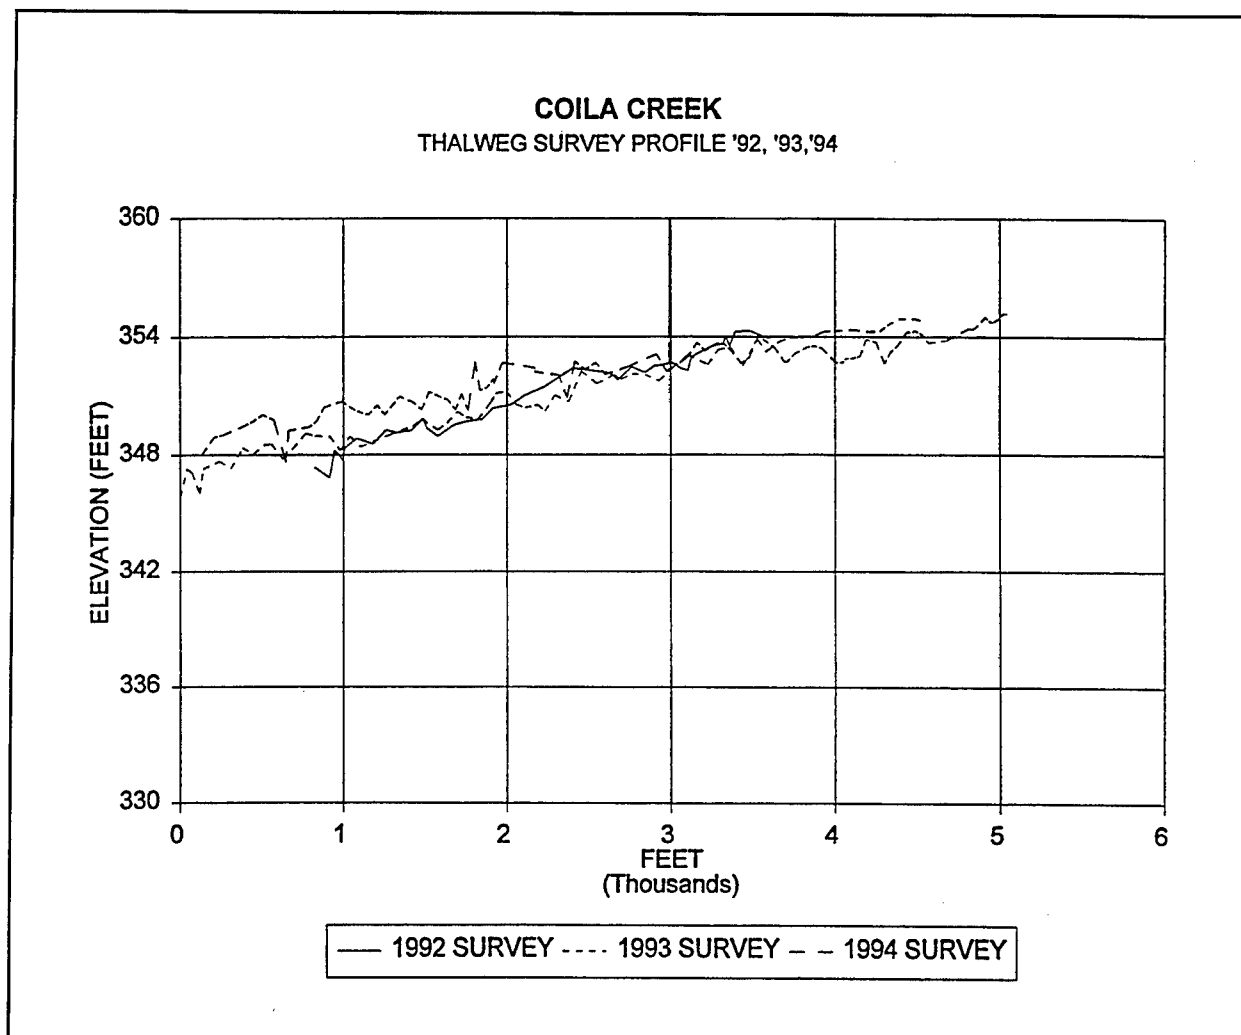
Figure 9. Coila Creek, Site 5, thalweg profile

Site 5 is actually located on Coila Creek, but is in the Abiaca Creek watershed. The site extends upstream approximately 4,000 ft from the confluence with Abiaca Creek as shown in Figure 8 in T17N, R2E, Section 4. The site has a watershed area of approximately 42 square miles, very similar to Site 4, which allows the comparison of two almost equal size drainage basins. SCS reservoirs control a high proportion of the Coila Creek basin, and the gravel mines on Coila Creek are not as active as those along Abiaca Creek. The thalweg profile indicated that some aggradation has occurred on the downstream portion of this site with little or no changes in bed elevations for the remaining portion (Figure 9).

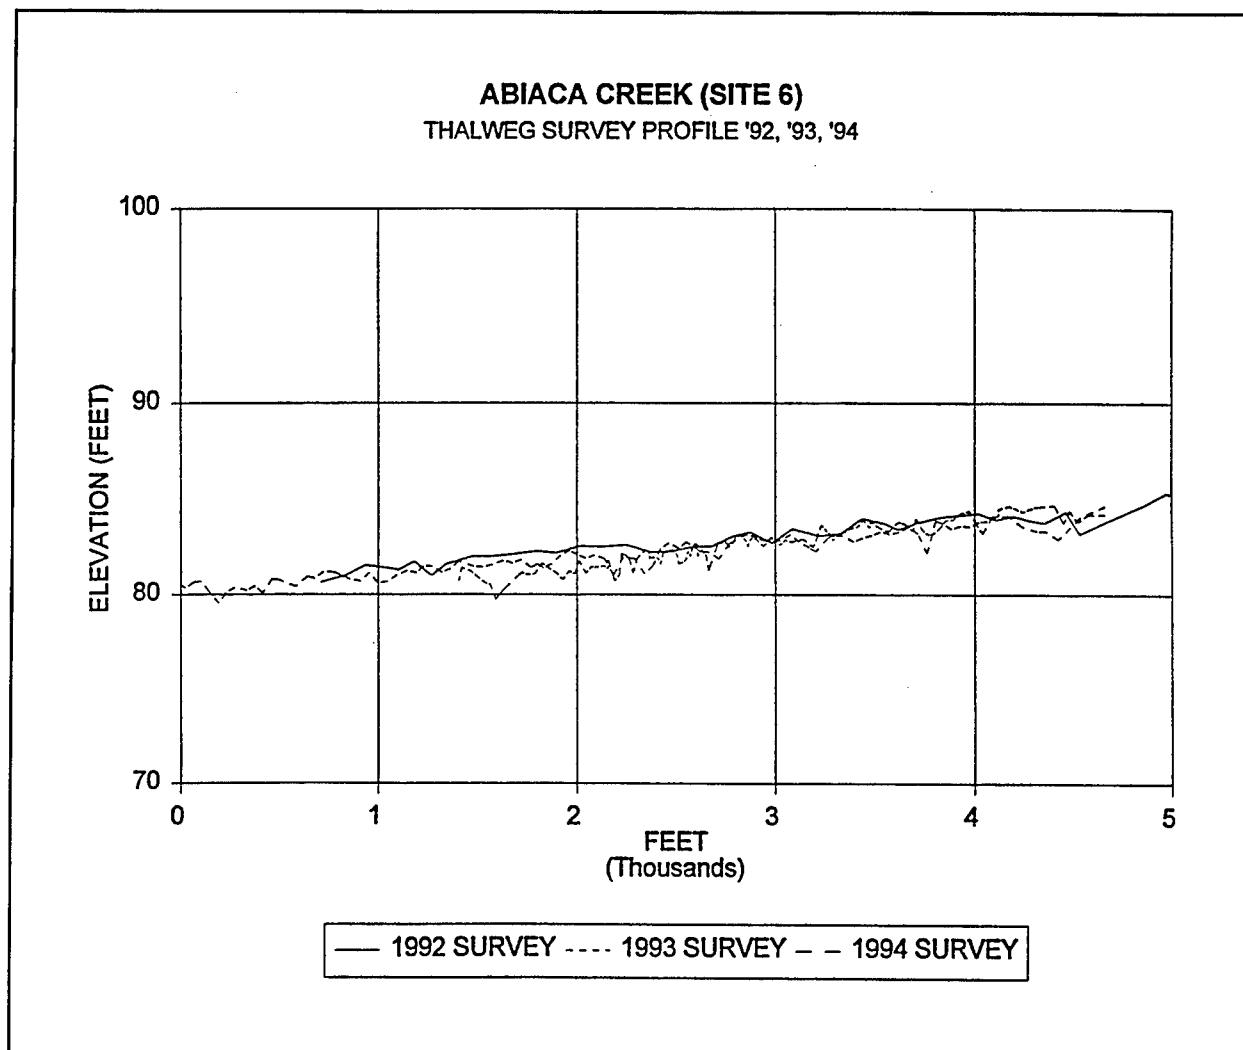
Figure 11. Abiaca Creek, Site 6, thalweg profile

pumped sediment sampler. The study reach extends approximately 4,000 ft downstream of the Pine Bluff gauging station. The thalweg profiles (Figure 11) indicate that local variation, primarily scour, has occurred on the order of 2 to 3 ft vertically.

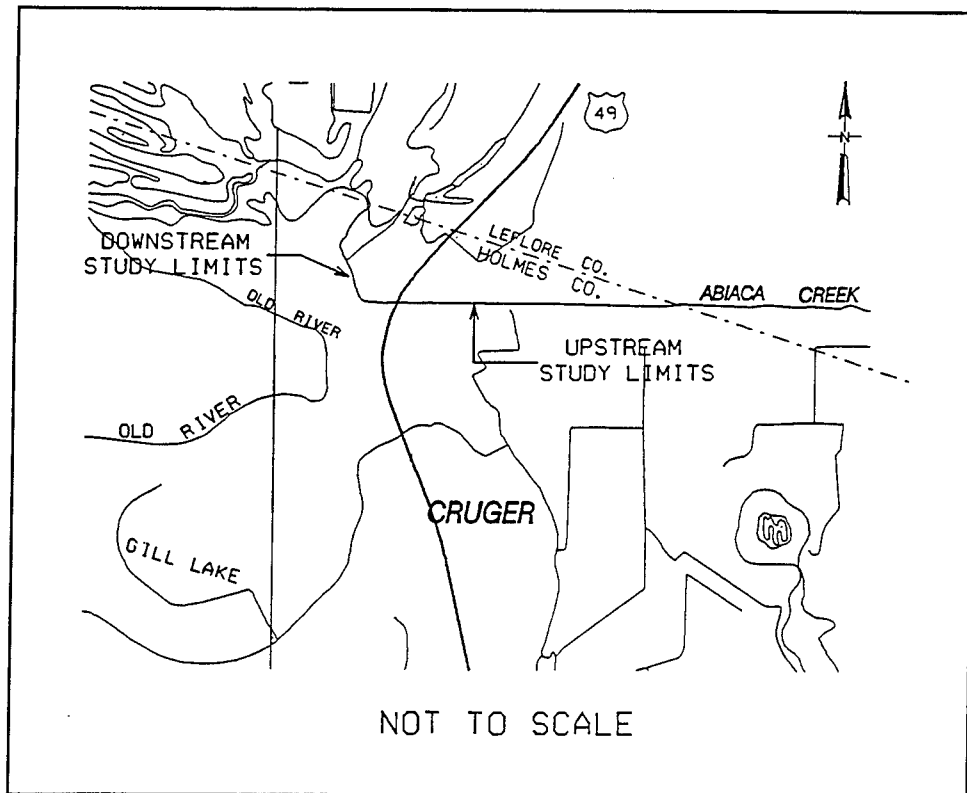
Figure 12. Abiaca Creek, Site 21

Site 21 is near the mouth of Abiaca Creek at Highway 49 as the stream enters the wildlife area, Section 18, T17N, R1E. The Vicksburg District has designed a sediment trap basin for this location by setting the levees back and allowing frequent overflow of the stream. The reach is approximately 4,000 ft in length and is shown in Figure 12. The thalweg profiles (Figure 13) indicate that local variation, primarily deposition, has occurred on the order of 2 to 3 ft vertically; however, it should be noted that surveys were taken on this site only in 1993 and 1994.

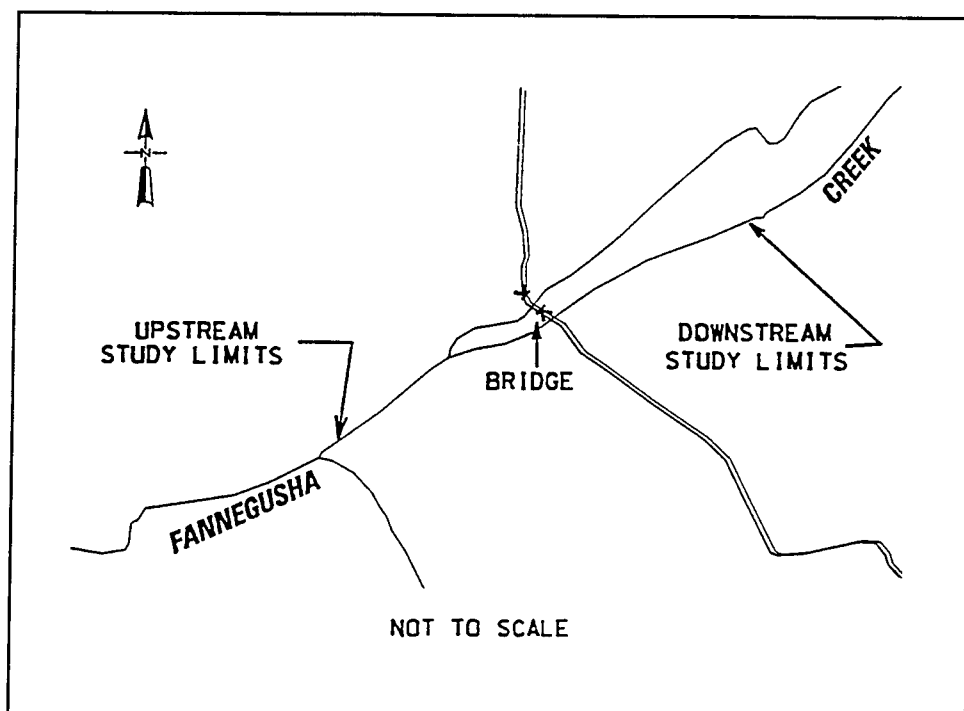
Figure 16. Fannegusha Creek, Site 2

Site 2 is located on Fannegusha Creek, in the Black Creek watershed and can be found on the Coila quadrangle map in T16N, R3E, Sections 1 and 2. The watershed area at the site is approximately 18 square miles. This reach was chosen as representing a very unstable sand bed channel. As shown in Figure 16, the study reach is approximately 4,000 ft in length, 2,000 ft upstream and downstream of a county road bridge. A low-drop structure was constructed in 1993 approximately 1,500 ft downstream of the bridge. The streambed appears to be aggrading for a distance of approximately 1,500 to

2,000 ft upstream of the structure. The bridge was replaced in 1994 due to channel widening. Observations indicate that the channel will continue to widen as over-steepened banks, due to previous bed degradation, continue to fail. Bed degradation upstream of the bridge will continue as a headcut progresses upstream. At present, the headcut is located approximately 1,200 ft upstream of the bridge.

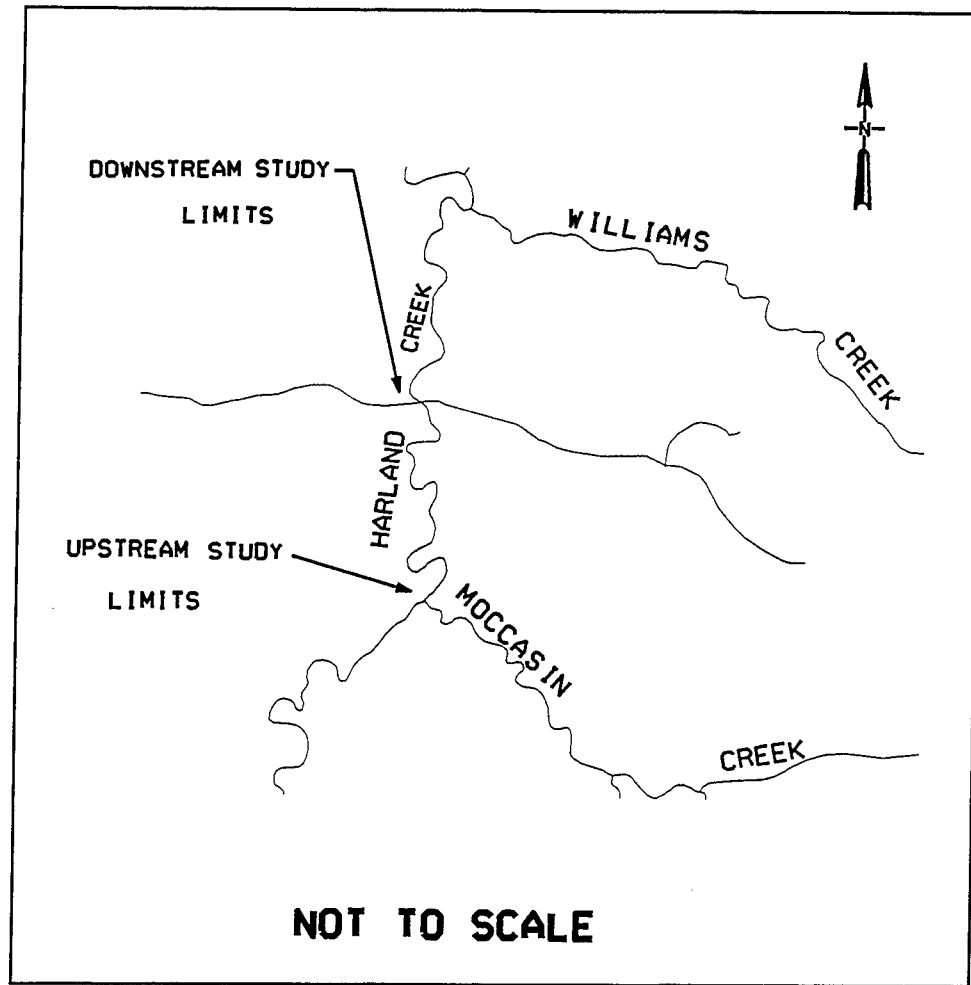
Figure 20. Harland Creek, Site 23

installed by the Vicksburg District. The site continues downstream for approximately 2 miles to the next county road bridge and encompasses an intensive bank stabilization treatment of willow posts and bendway weirs. The site is located in T14N, R1E, Section 11 (Figure 20).

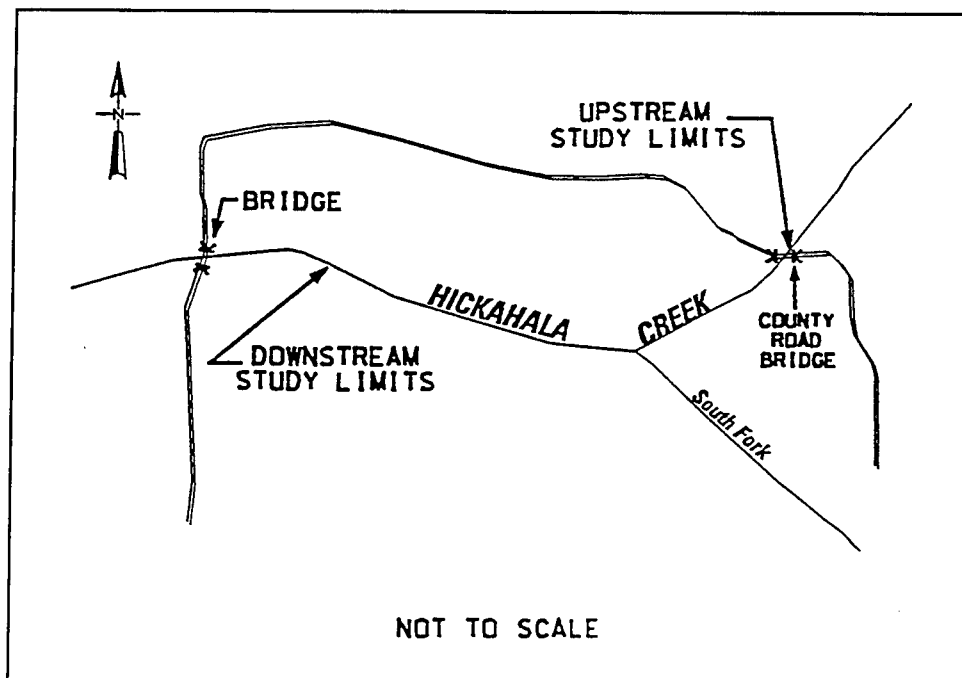
Figure 22. Hickahala Creek, Site 11

Site 11 is located in the upper watershed of Hickahala Creek, and has a watershed area of approximately 9 square miles. The site is located on the Tyro quadrangle map in T5S, R5W, Sections 2 and 3, a portion of which is shown in Figure 22. The site begins at a county road bridge and extends downstream to the confluence with the South Fork, and continues downstream

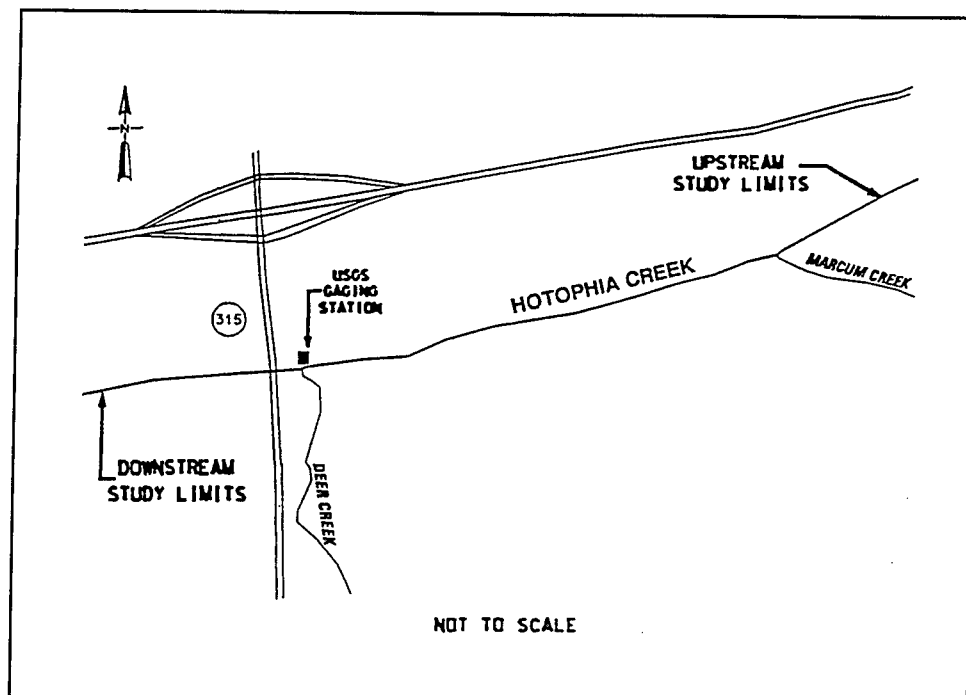
Figure 24. Hotophia Creek, Site 13

Site 13 is located on Hotophia Creek, west of Oxford. As shown in Figure 24, the site encompasses approximately 2 miles of Hotophia and Marcum Creeks and is located on the Sardis quadrangle map in T9S, R6W, Sections 1 and 2, and in T9S, R5W, Section 6. The watershed area at the site on Hotophia Creek is approximately 17 square miles. A USGS gauging station is located at the Highway 315 bridge crossing of the creek. The study reach includes the confluences of Marcum Creek and Deer Creek with Hotophia Creek. A low-drop is located at the downstream extent of Hotophia Creek and a high-drop is located on Hotophia Creek immediately downstream of the confluence with Marcum Creek. Two low-drops are situated on Deer Creek, and one low-drop is located on Marcum Creek approximately 800 ft upstream of the confluence with Hotophia Creek. Two additional high-drops, one within

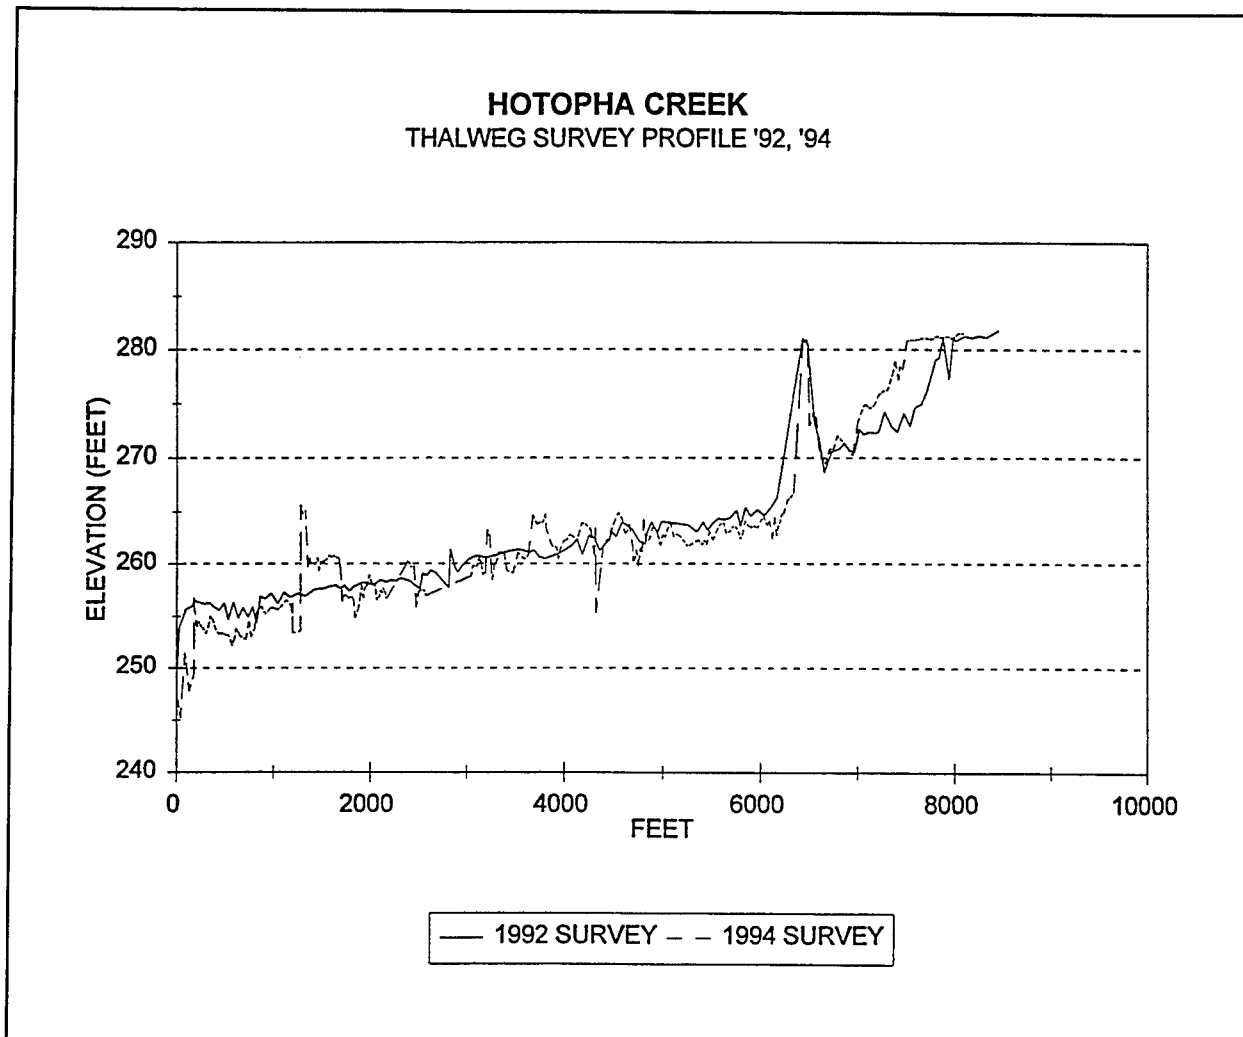
Figure 25. Hotopha Creek, Site 13, thalweg profile

The primary change in the thalweg profile of Hotophia Creek during 1992-1994 is due to the construction of the downstream high-drop structure and the filling of the next upstream structure (Figure 25). The downstream extent of the study reach is the older low-drop structure, referred to as No. 8, which is downstream of Highway 315. This structure appears unchanged from last year, with a significant drop at the downstream extent of the riprap. However,

the water depth upstream seems to have increased from previous years and debris on the channel bed is visible from top bank looking down through the water column. A severe gully was observed on the left bank immediately downstream of the Highway 315 bridge and adjacent to an existing drop pipe. Apparently, the flow has bypassed the drop pipe and is causing a new gully along the downstream edge of existing riprap. Immediate attention is needed at this site. Another gully within the riprap is apparently causing sediment accumulation upstream of the high-drop structure. The channel flow is backwatered to the next high-drop, with little change in the channel. Sediment has accumulated upstream of the second high-drop down to the Marcum Creek confluence, with a slightly meandering channel forming in the newly aggraded sediment. Marcum Creek is inundated to within 300 ft of the Marcum Creek low-drop.

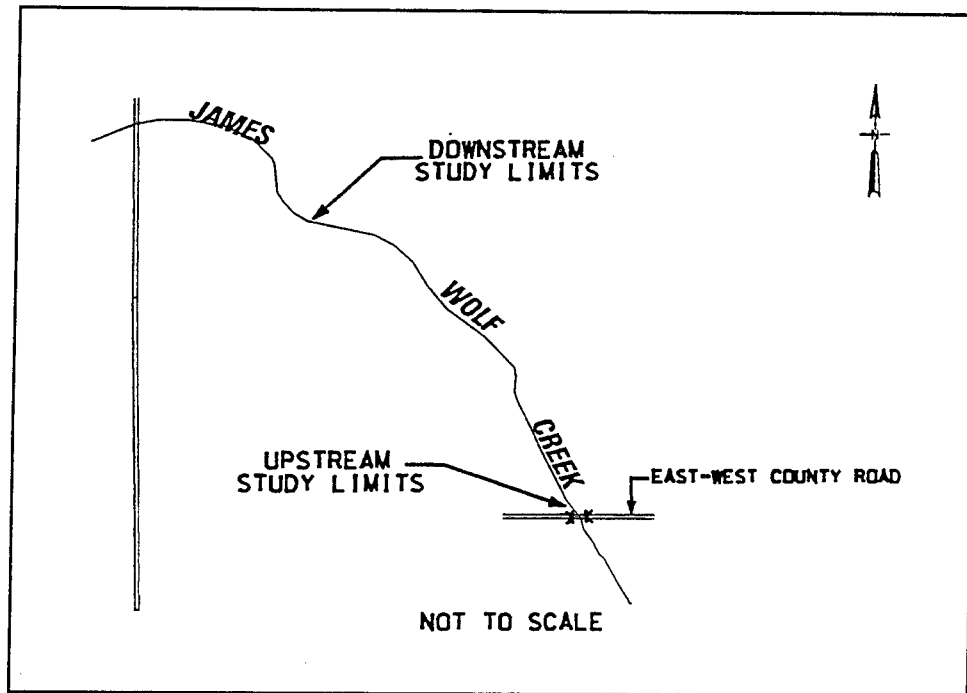
Figure 26. James Wolf Creek, Site 19

miles; however, it is extremely deep and wide. The site is located on the Tyro quadrangle map in T5S, R5W, Section 28, and extends downstream of the east-west county road for a distance of approximately 4,000 ft encompassing a low-drop structure (Figure 26). This low-drop structure appears to be stabilizing the bed of the stream; however, the banks remain unstable due to the significant depth. The stream has a sand bed, and at low-flow conditions, the channel may be dry. The drop structure has required significant repair since construction and is presently in need of significant repair. Two additional drop structures were constructed on James Wolf Creek downstream of the monitoring reach during 1993 and 1994.

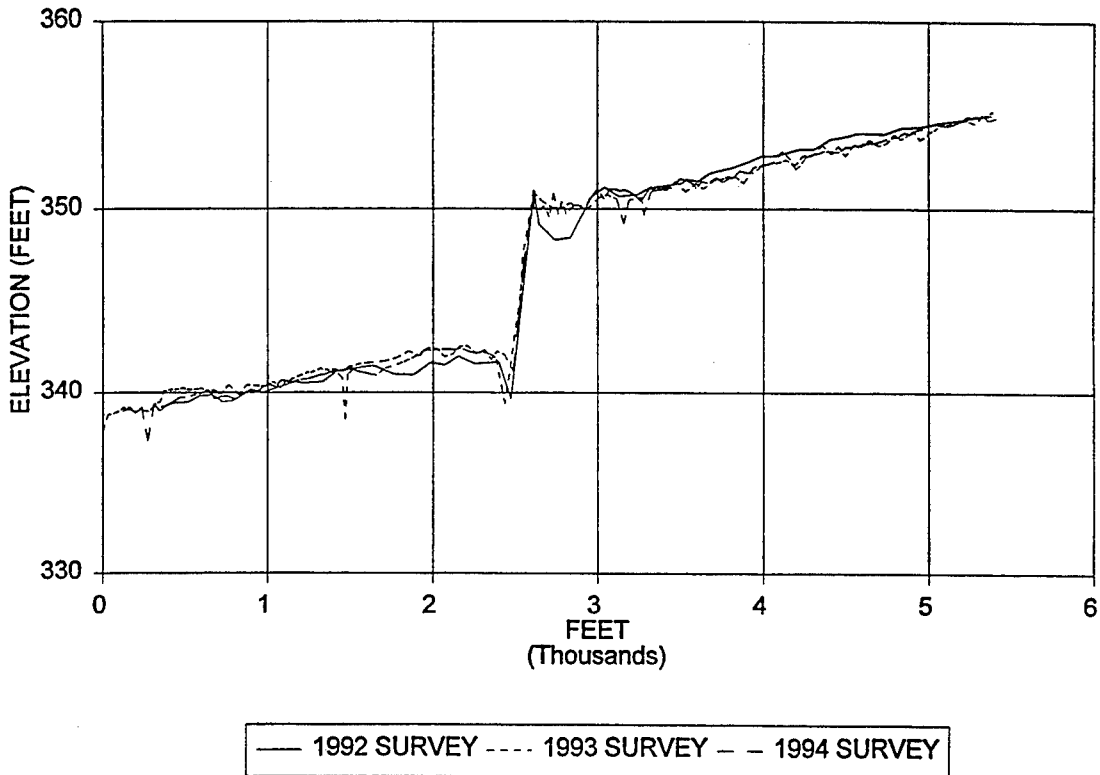
Figure 27. James Wolf Creek, Site 19, thalweg profile

The thalweg profile (Figure 27) indicates that no significant change has occurred during the past three surveys. The upstream scour feature has completely filled for the 1993 and 1994 surveys. A large beaver dam exists on the upstream riprap approach. Apparently, the beaver prefer the riprap foundation for their construction site. A backwater condition exists from the beaver dam to the upstream tributary on the left bank at approximate station 33+00. About 250 ft downstream from the upstream bridge, willows are establishing on an island in the center of the channel. Heavy kudzu growth dominates the bank vegetation. Riprap movement at the structure has been severe over the years and is continuing. No movement or cracking of the weir cap was noted.

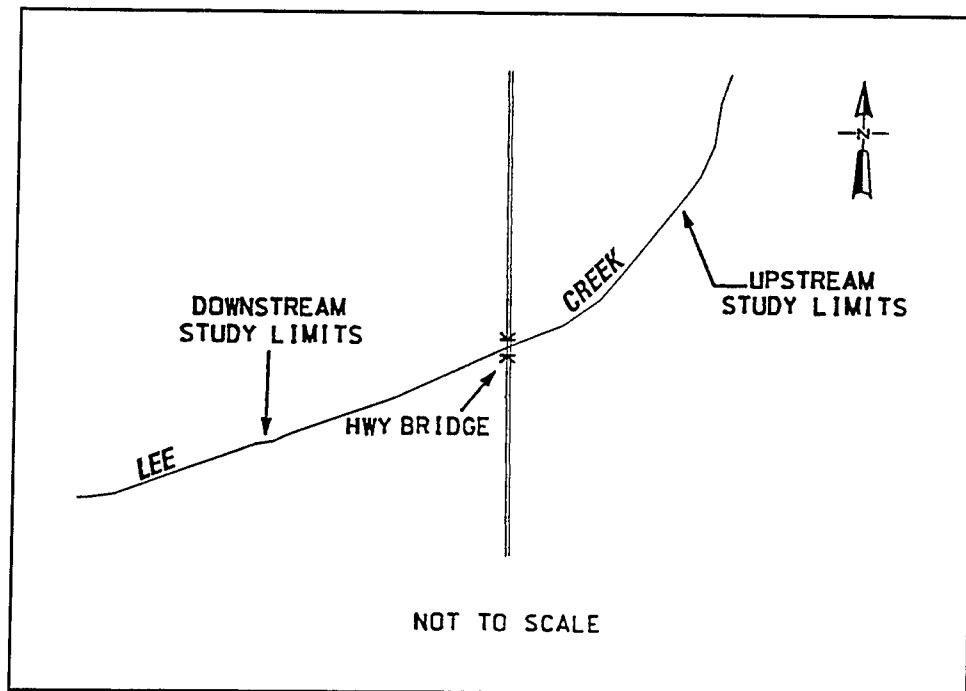
Figure 28. Lee Creek, Site 10

in T2S, R4W, Sections 9 and 10 (Figure 28). The study reach extends approximately 2,000 ft upstream and downstream of the highway bridge. The channel is relatively stable and is transporting minor amounts of gravel in a sand bed. Upstream of the bridge, the channel exhibits some meandering and apparently has not been channelized. Downstream of the bridge, the channel is stable with mature, 14-in.-diameter trees near the low-water surface. The remnants of spoil piles indicate that downstream of the bridge, the channel has been channelized. This reach provides an excellent opportunity to document a stable, channelized, sand-bed stream.

During October 1994, the property owner at the Lee Creek site requested that a drop pipe be considered for the left bank in the field upstream of the bridge that is immediately upstream of the Lee Creek site. He also suggested that the channel flood conveyance be improved within the upstream portion of the Lee Creek site. The upstream portion of the study site is in a cotton field with the channel banks covered by kudzu. The downstream portion of the study site is in pasture with grassed banks and a birch tree canopy. The downstream banks are relatively stable and conveyance is good, which is in direct contrast to the upstream portion of the study site. Kudzu has killed most competing vegetation in the upper portion. Only willow trees on islands within this small channel have been able to compete. The islands grow, creating divided flow, collecting debris, and reducing conveyance. Channelization to match the downstream channel section, eradication of kudzu, and planting of a mixture of grasses and birch trees could duplicate the downstream portion of the site and improve conveyance. Bridge abutments at the road crossing in the center of the study site are also in poor condition.

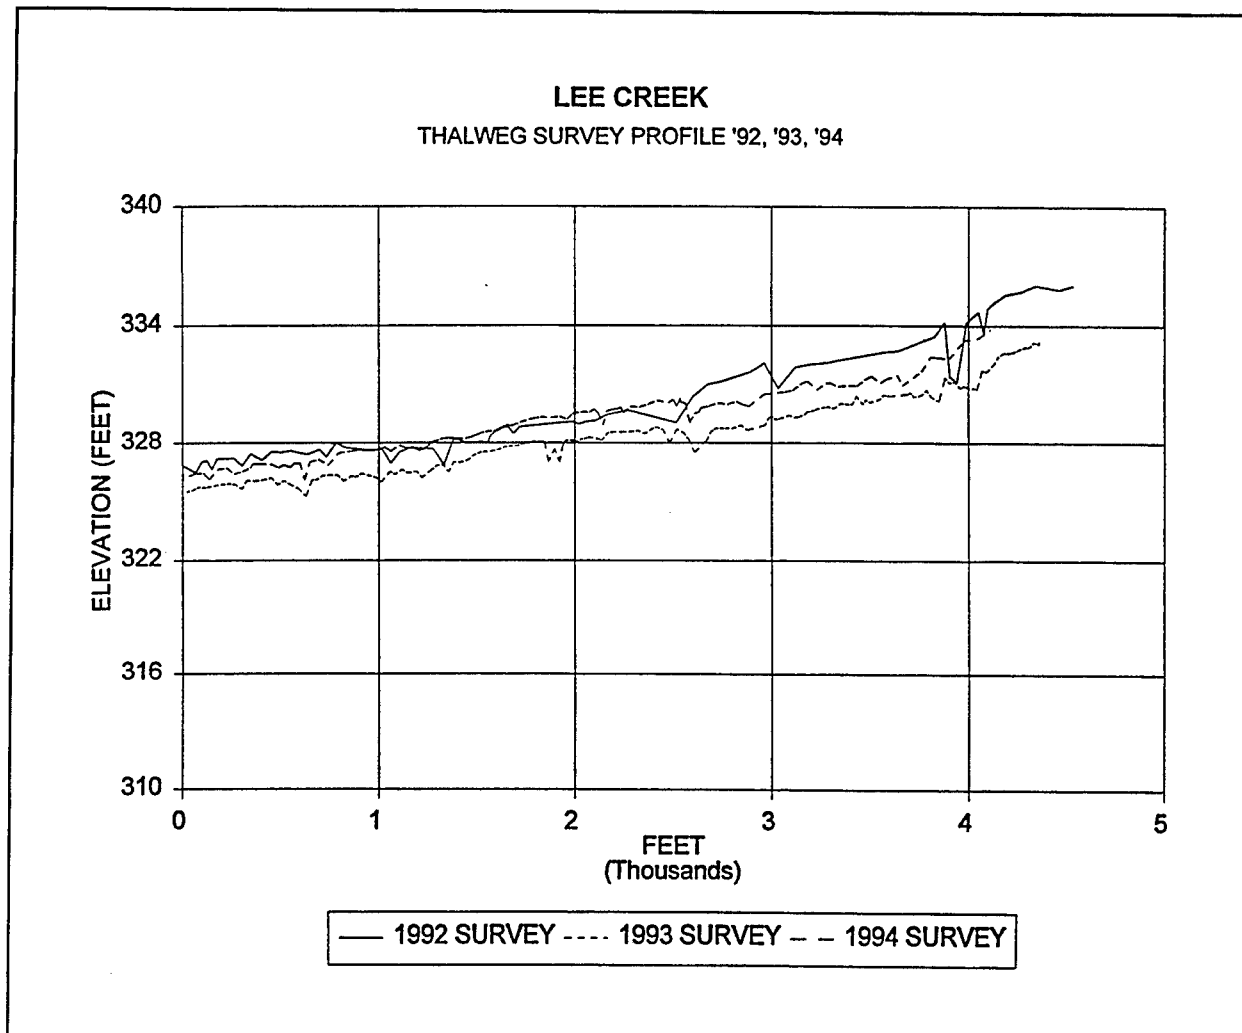
Figure 29. Lee Creek, Site 10, thalweg profile

Based on the channel profiles (Figure 29), from 1992 to 1994 channel degradation in the range of 2 to 4 ft occurred. Any channelization of the upstream portion of the site should include extending the survey upstream and consideration of grade control. BURBANK analysis confirms the field observations that the channel banks are stable. The 2-year water surface slope of the reach is 148 percent of the slope and 177 percent of the width for the width and slope required to transport 1,000 mg/l at minimum slope, as defined by SAM (Table 16).

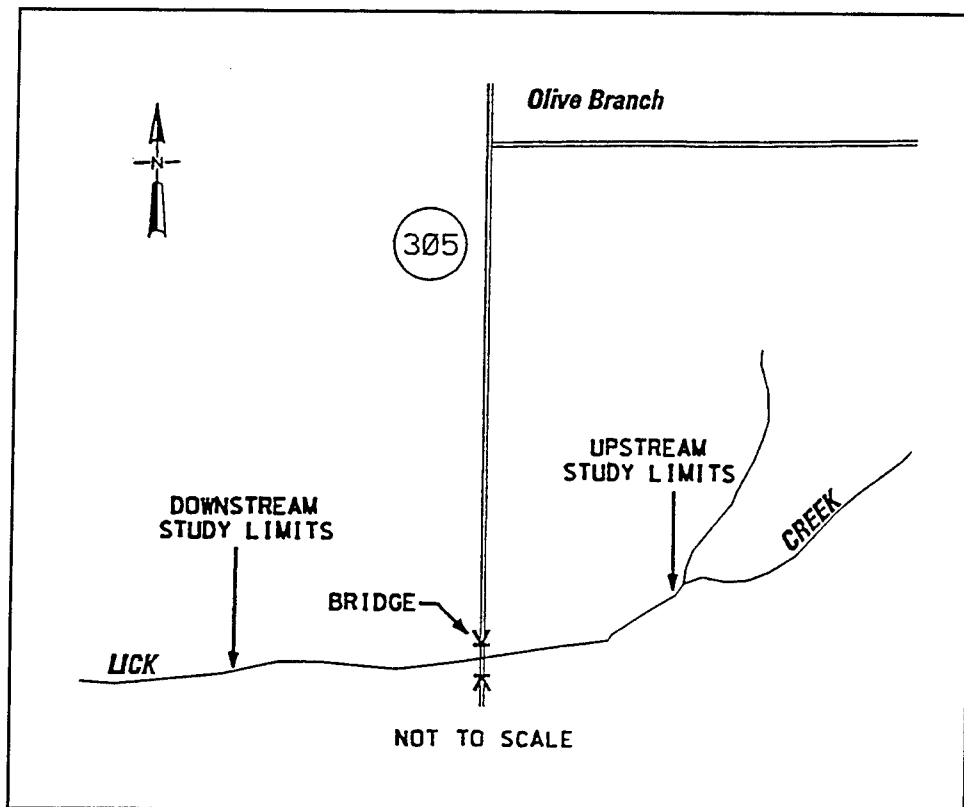
Figure 30. Lick Creek, Site 8

Site 8 is on Lick Creek in the Coldwater River basin, approximately 2 miles south of Olive Branch, MS. Construction of a high-drop structure was started in late 1994 to protect the Highway 305 Bridge. As shown in Figure 30, the study reach is approximately 4,000 ft in length, 2,000 ft

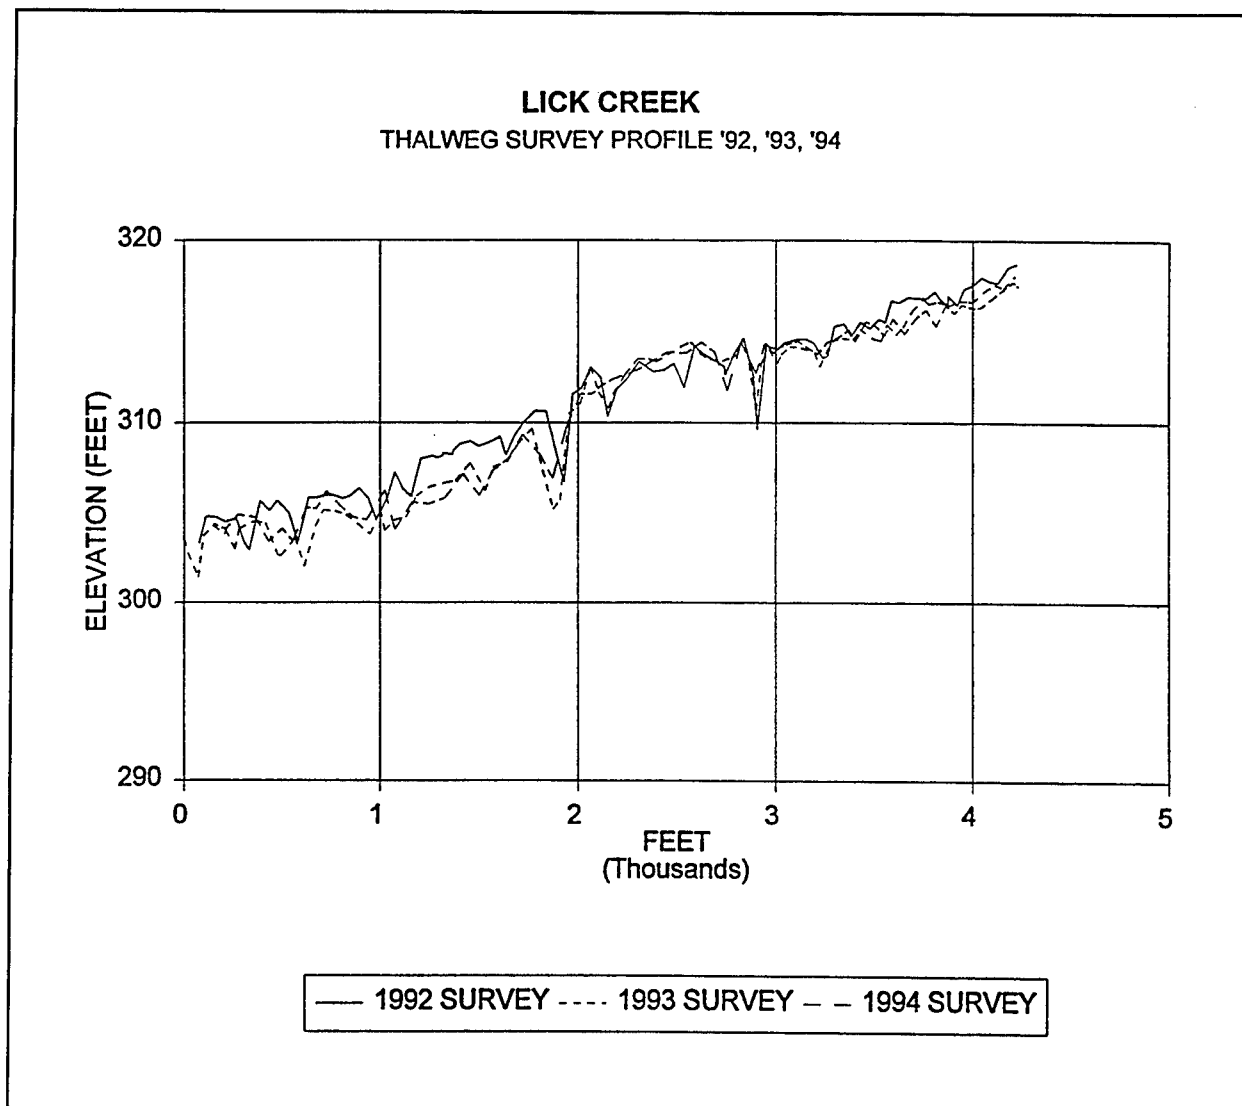
Figure 31. Lick Creek, Site 8, thalweg profile

The high-drop structure is located at approximate station 18+00 of the accompanying thalweg profile (Figure 31). Riprap placed at the bridge (station 20+00) as a temporary measure during construction of the structure has slowed the incision that is continuing upstream and downstream of the bridge. Degradation is continuing downstream of the structure and can be expected to continue after the closure of the structure. Backwater from the structure should assist in halting the upstream incision if the knick zones have not progressed too far upstream to be affected by the high-drop. The high-drop structure will protect the highway bridge. Presently, the upstream extent of the site is incising into resistant clay.

BURBANK analysis indicates that 3 ft of additional degradation will destabilize 19 percent of the surveyed banks. Left bank drainage upstream of the bridge is poor, with standing water in the adjacent field. Channel incision and a saturated left bank may combine to result in greater instability than in other similar streams. A drop pipe could be added to improve the bank drainage in that area. The SAM analysis indicates that the width has been increasing and the slope has been decreasing since the initial 1992 survey.

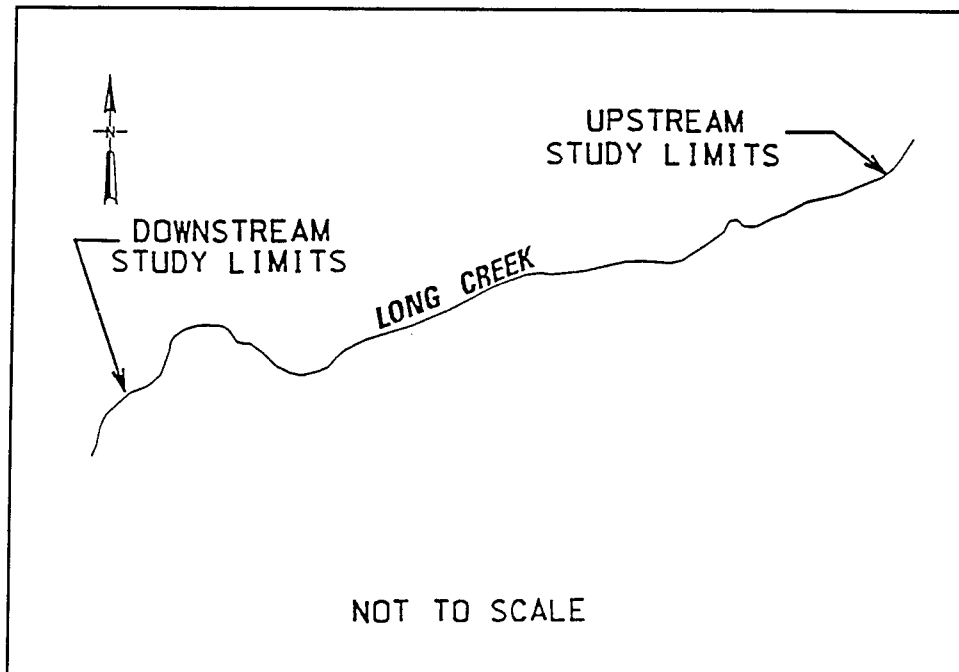
Figure 32. Long Creek, Site 20

Site 20 is located on Long Creek, T10S, R6W, Sections 4, 5, and 8, as shown in Figure 32. The site can be found on the Oakland quadrangle map and has a watershed area of about 11 square miles. Three low-drop structures existed prior to 1991 and the fourth was constructed in 1993 at the downstream limit of the monitoring reach. A fifth structure was constructed in 1993 downstream of the reach. The study reach is approximately 2 miles in length,

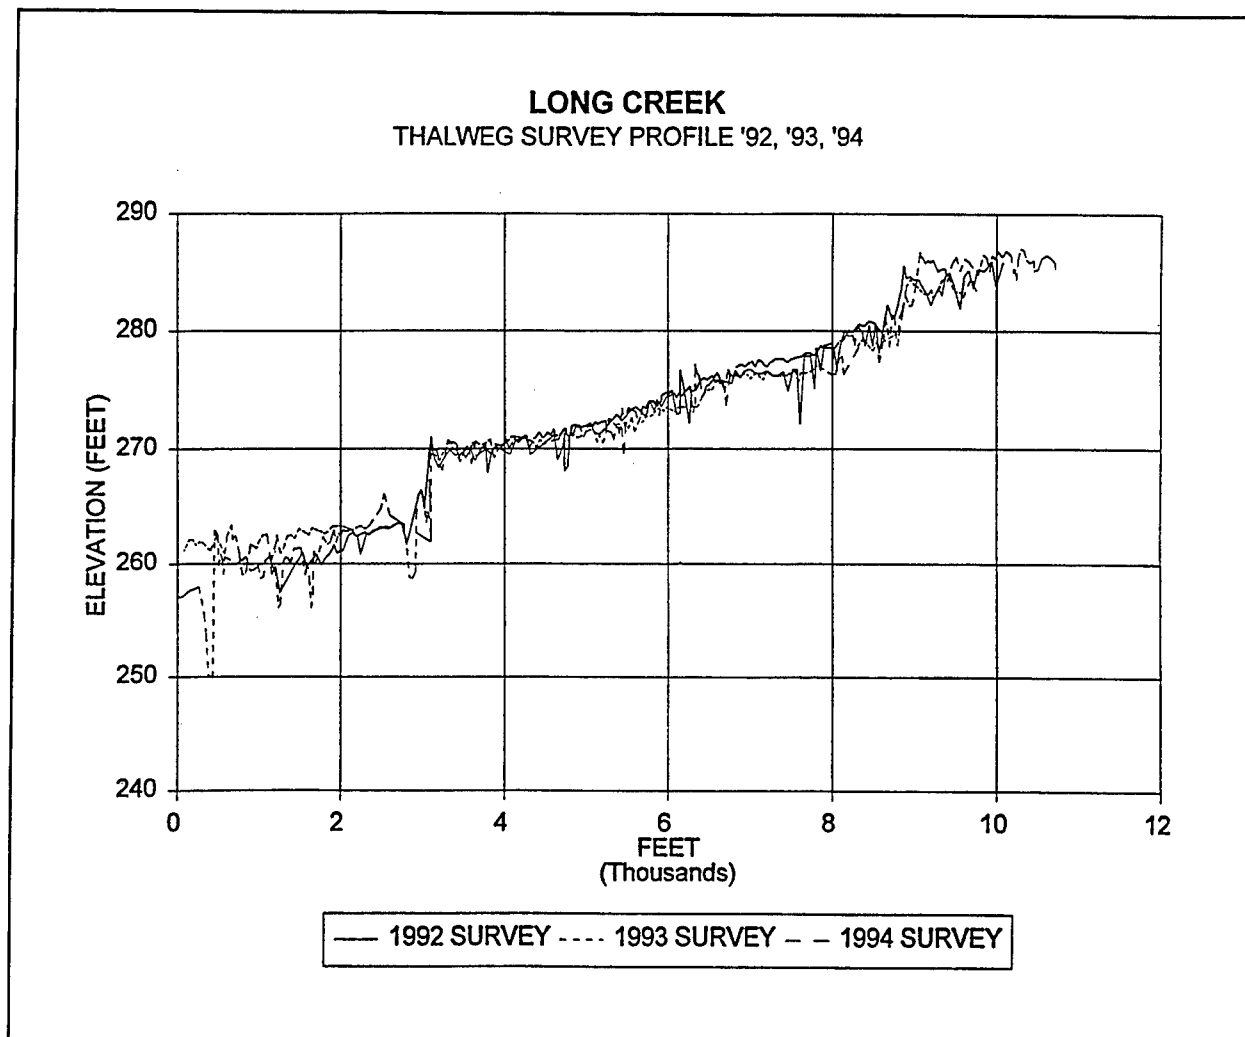
Figure 33. Long Creek, Site 20, thalweg profile

Long Creek is divided into four segments: at station 0+00 at the fourth downstream drop structure; at approximate station 32+00 at the older low-drop structure; at approximate station 68+00 at the next upstream low-drop structure; and at approximate station 90+00 at the upstream structure. This structure at station 90+00 is a weir, not a low-drop structure, and is an at-grade sheet pile and concrete capped structure with no stilling basin. Figure 33 shows the thalweg profiles of Long Creek. Segment 1 aggradation has resulted since 1992 with the completion of the lower drop structure in 1993. The other significant thalweg change is within 300 ft downstream of the upper weir where headcutting is moving into the structure. The most significant change from 1993 is the number of beaver dams that are present in segments 2, 3, and 4.

BURBANK analysis shows the significant improvement in bank stability in segment 1 from 79 percent at risk in 1992 to 10 percent at risk in 1994 (Table 18). Bank instability in the remaining three segments is generally less than 10 percent. Without structural control, degradation would be continuing. The effects of 3 ft of degradation range from 69 percent in segment 1 to 25 percent in segment 3, which demonstrates one of the positive aspects of low-drop grade control. SAM analysis demonstrates the reduction in segment 1

slope, and shows the lower width in segments 3 and 4 where longitudinal riprap is placed on both channel banks almost continuously. The slopes for these two segments are approximately double the slopes for segments 1 and 2. Headcutting is present in segment 4. Monitoring of the long-term slope adjustment of the site will furnish unique information pertaining to channel adjustment in a channel that is limited in width adjustment. From an operational viewpoint, degradation is moving up to the upstream weir and should be monitored for the safety of the structure.

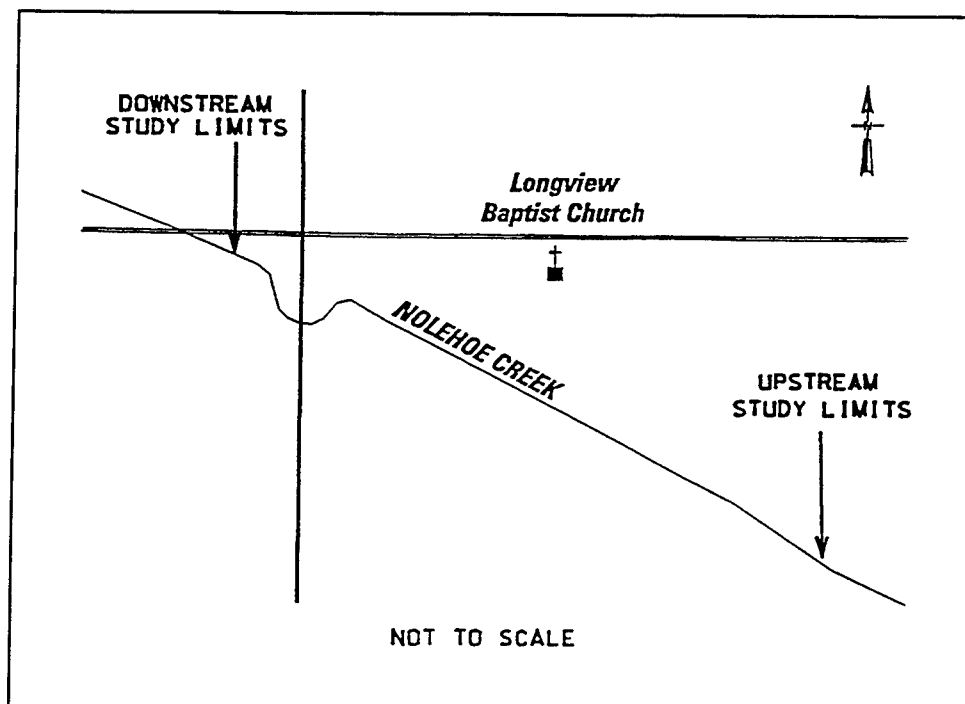
Figure 34. Nolehoe Creek, Site 7

Site 7 is located on Nolehoe Creek in the Coldwater River basin near the community of Olive Branch. The site is located on the Hernando quadrangle map, T1S, R7W, Section 35, and has a drainage area of approximately 3.7 square miles (Figure 34). The study reach is approximately 4,000 ft in

length, extending downstream from a box culvert. The channel is extremely unstable and is deeply incised. Bed material load ranges in size from fine sand to gravel with a mean diameter in excess of 30 mm. Two low-drop structures are planned for the reach; however, permission to construct the structures has not been received from the landowner. Stream stage recording stations have been recently installed by WES at the downstream roadway culvert.
